AD NUMBER	
AD357977	
CLASSIFICATION CHANGES	
TO:	UNCLASSIFIED
FROM:	SECRET
LIMITATION CHANGES	
TO: Approved for public release; distribution is unlimited. Document partially illegible.	
FROM: Distribution authorized to U.S. Gov't. agencies only; Administrative/Operational Use; 1953. Other requests shall be referred to Atomic Energy Commission, Washington, DC. Document partially illegible.	
AUTHORITY	
AEC ltr 16 Jun 1980 ; AEC ltr 16 Jun 1980

The purpose of Signal Corps participation in Project 3.20 was to determine the amounts of thermal flux (cal) and peak overpressure (psi) required to cause severe, moderate, light, and negligible damage to selected signal communications-electronics items of equipment and material for which inadequate or no data existed. Knowing these factors it is believed that responsible signal officers can better plan their tactical communications systems and take passive protective measures to reduce damage and losses to acceptable minimums. These data will also be used to improve design of equipment and material.

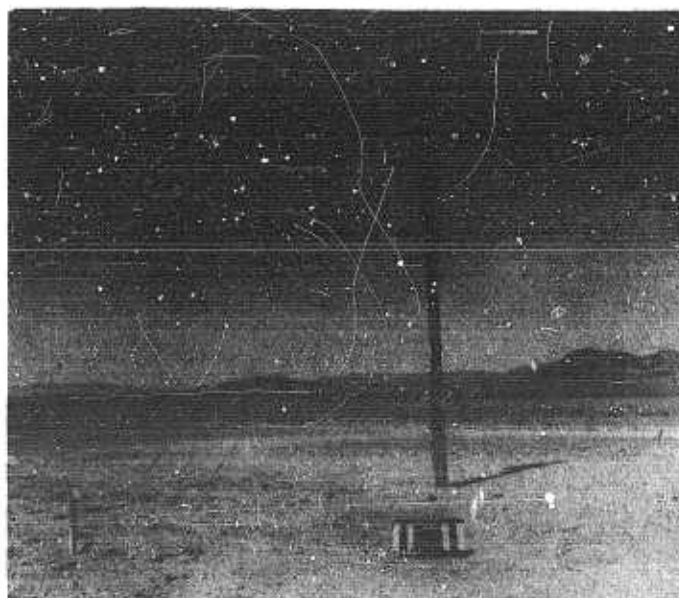
Fig. 3.1 Shot 9, Test Group 1, Radial Pole Line, Pole D-1
(Top-before, Bottom-after) (EE-8 Field Telephones
in Bottom View were Installed Prior to Shot 9.)
9080 ft, 8 cal, 3 psi

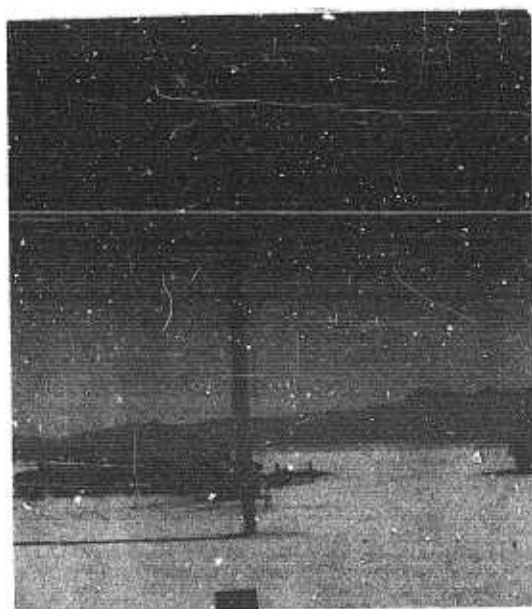
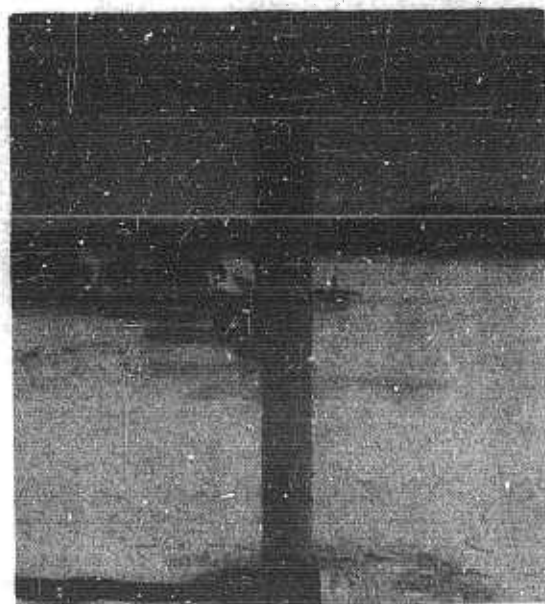
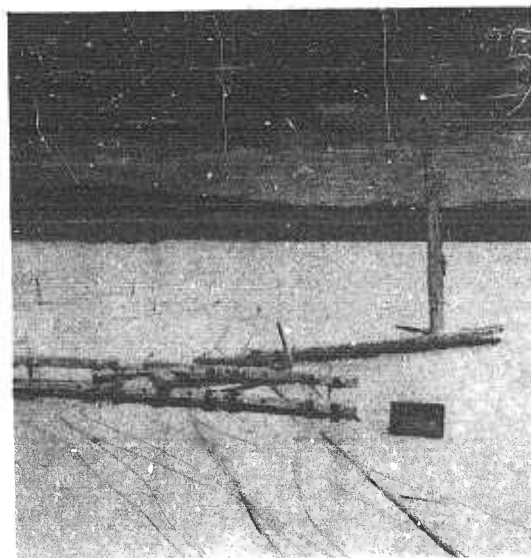
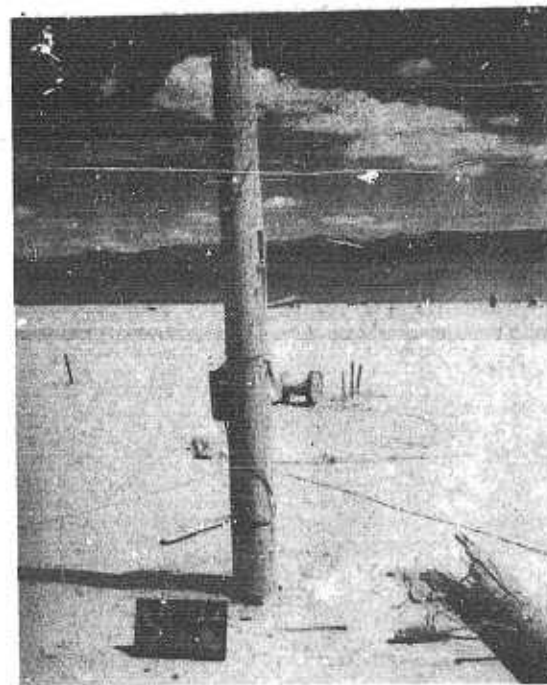
(4) GLASS INSULATORS: Several of the glass insulators were broken. Those not broken were serviceable.

Fig. 3.25 Shot 9, Test Group 24, Transverse Pole Line, Pole C-1.
 (Top-before, Bottom-after). Close ups of same Pole
 (Top-before, Bottom-after). 3425 ft, 50 cal, 9.6 psi.

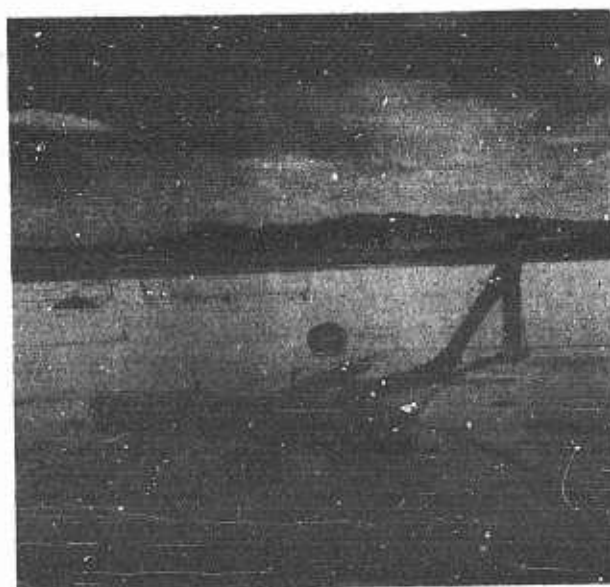
Fig. 3.34 Shot 9, Test Group 27, Transverse Pole Line, Pole
B-1. (Top-before, Bottom-after)
4450 ft, 35 cal, 7 psi.

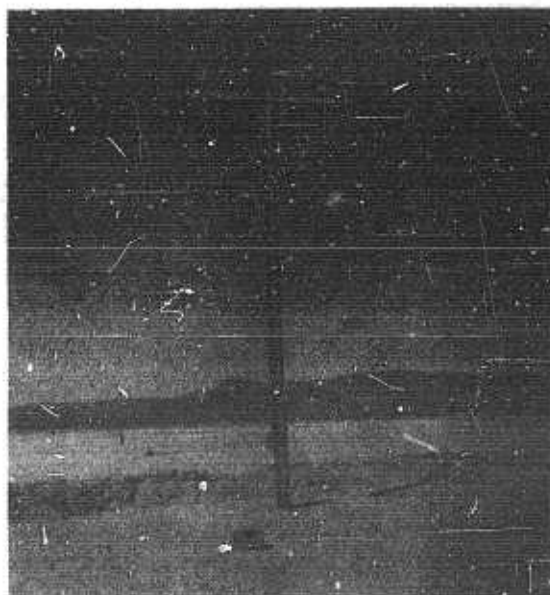
(11) CABLE TRANSFER RELAY: This relay on pole A-4 received no visible damage. A laboratory analysis indicates that this relay received no electrical or structural damage and it would have been serviceable.

Fig. 3.43 Shot 9, Test Group 30, Transverse Pole Line, Pole A-1. (Top left-before, Bottom left-after) Close-ups of EE-8 Telephone and TM-184 Terminal Strip on Shielded Side of Pole A-1. (Top right-before, Bottom right-after) 5425 ft, 25.5 cal, 5.6 psi.

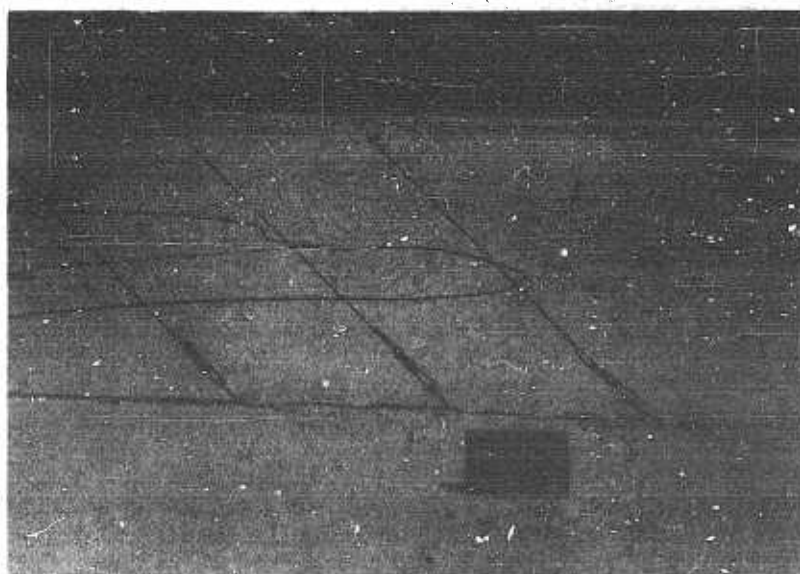
Fig. 3.51 Shot 9, Test Group 30, Transverse Pole Line, Triple Guys and Anchors on Pole A-8. (Top-before, Bottom-after)
5425 ft, 25.5 cal, 5.6 psi.

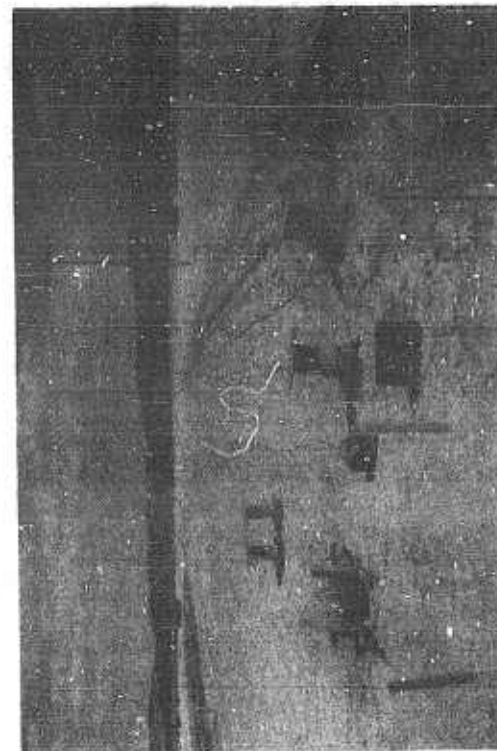
Fig. 3.52 Shots 9 and 10, Test Groups 2 and 2A, Surface Laid Wire and Cable. (Top left-before 9, Top right-after 9, Bottom-after 10) In Top View Cable Reels in Readiness to Lay along Ground Zero Just Prior to Shot 9. In Bottom View Photo Taken 2100 ft North Looking Toward Ground Zero. Shot 9, 1250 ft, 113 cal, 16.6 psi. Shot 10, 2100 ft, over 65 cal, 7.5 psi (at 2100 ft)

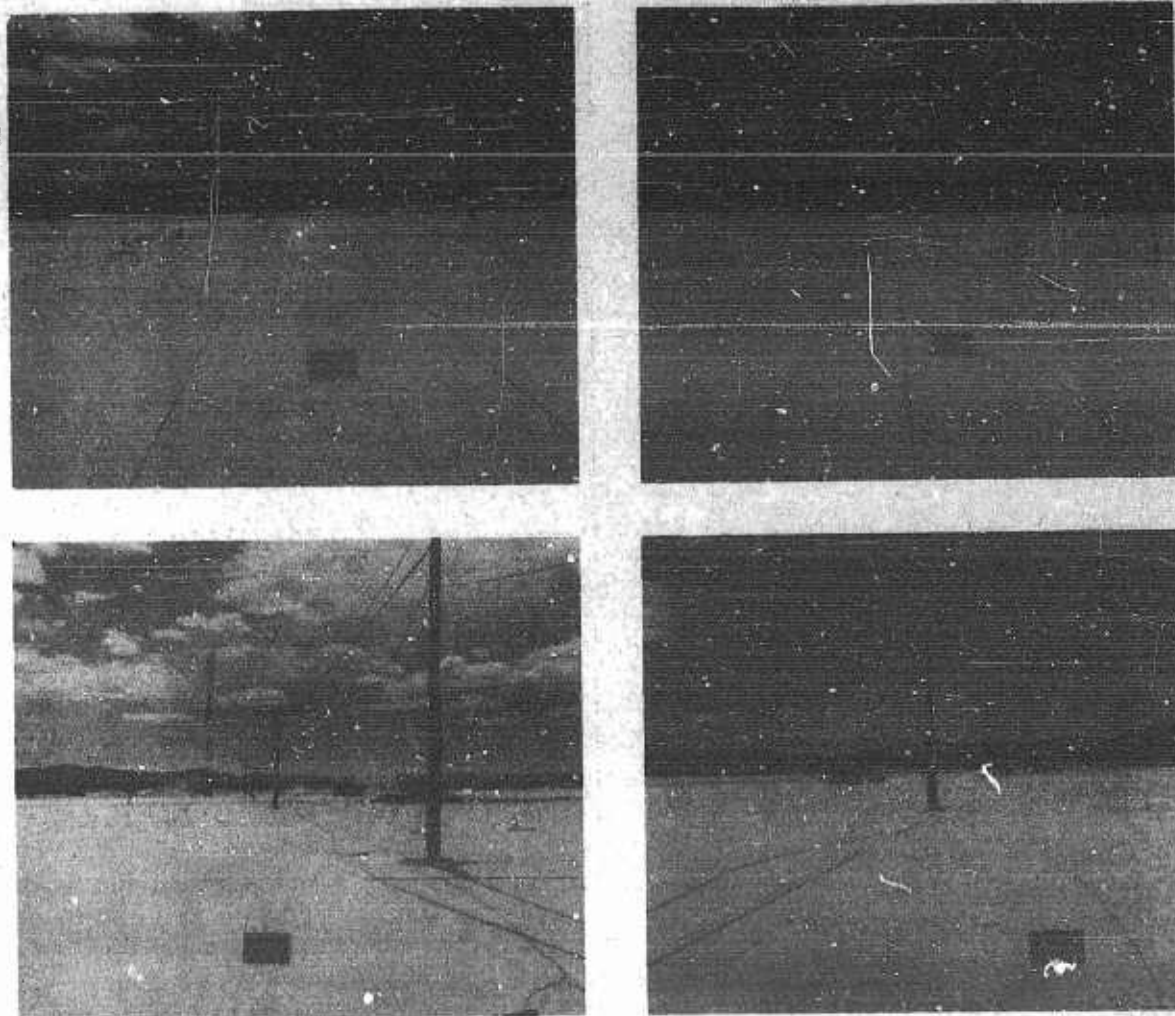
Fig. 3.56 Shot 9, Test Group 31, Surface Laid Wire and Cable Along Transverse Pole Line. Photos taken from Center of Lays Facing West. (Top-before, Bottom-after) Photos taken from Center of Lays Facing East. (Top right-before, Bottom right-after) 5400 ft, 25.5 cal, 5.6 psi.

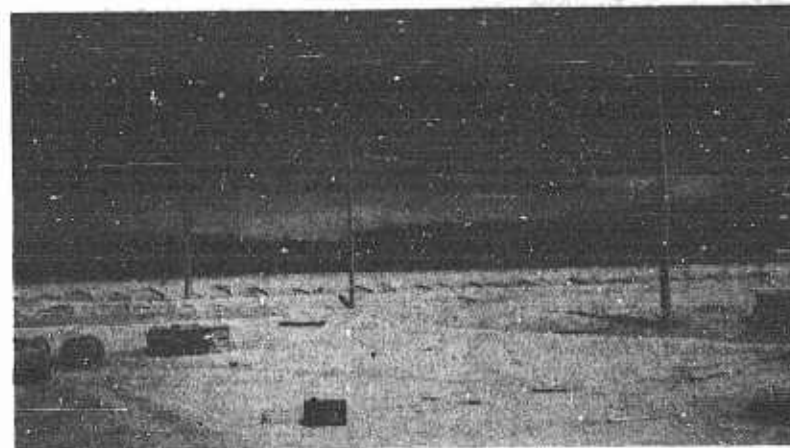
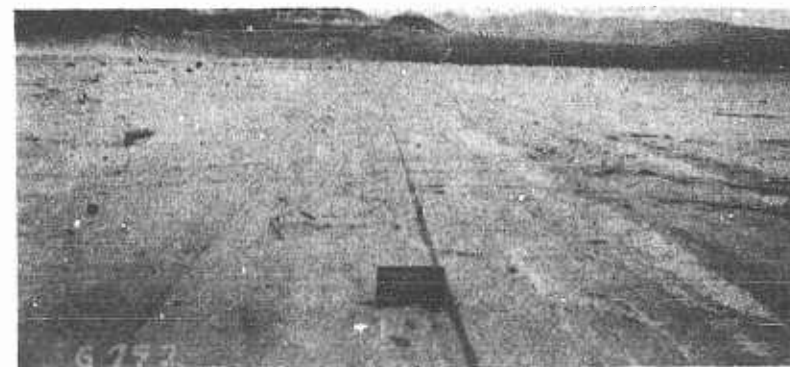
Fig. 3.58 Shots 9 and 10, Test Groups 4 and 4A, Separate Poles. (Top-before 9, Center-after 9, Bottom-after 10) (In Bottom View Note the Foxhole on Left Hand Side of Photo - Test Group 4A was about 1000 ft forward and 25 ft to the Left of this Foxhole. The Three Poles were Disintegrated in Shot 10) Shot 9 - 1850 ft, 85 cal, 13.2 psi. Shot 10 - 1120 ft, over 60 cal, 32 psi.

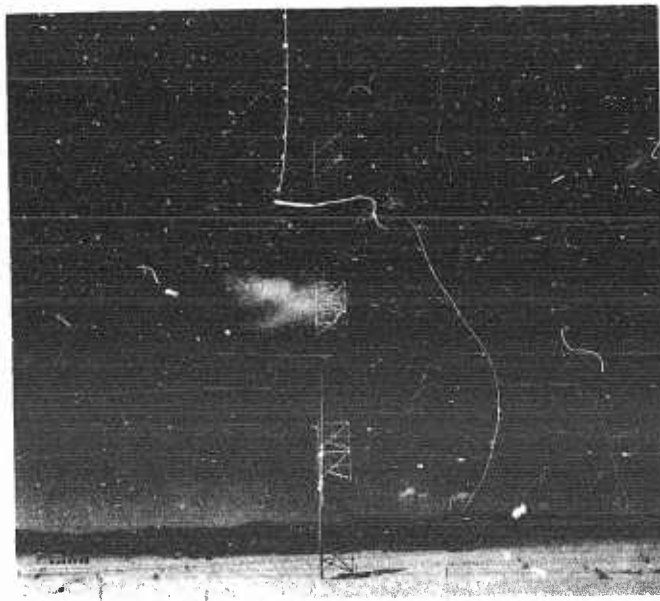
b. RESULTS: Severe damage by blast forces. Tower collapsed. Study of high speed photography indicates that basic tower failure occurred between ground and the first guy level. The base and third section from bottom were demolished. Members were severely bent or broken. Adjustable feet at base section were severed. Examination of individual tower sections revealed that only 5 sections could be reused. Fifteen sections were sufficiently damaged to require replacement. Small diagonals (1 inch diameter tubing) in many of the damaged sections failed in either tension or compression. The tensile failure caused the two rivets to be sheared at either end of the diagonal. The compression

Fig. 3.86 Shot 9, Test Group 33, Tower, 120 ft.
(Top-before, Bottom-after)
3350 ft, 51.5 cal, 9.8 psi.

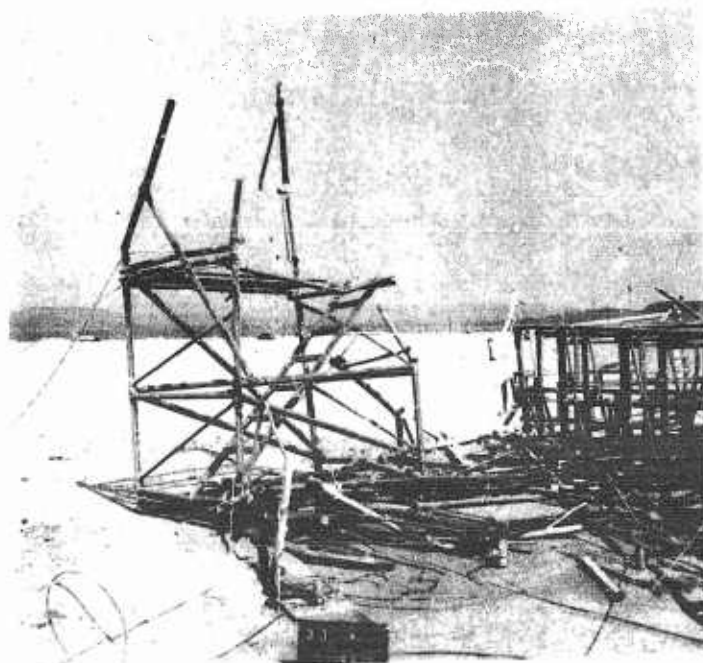
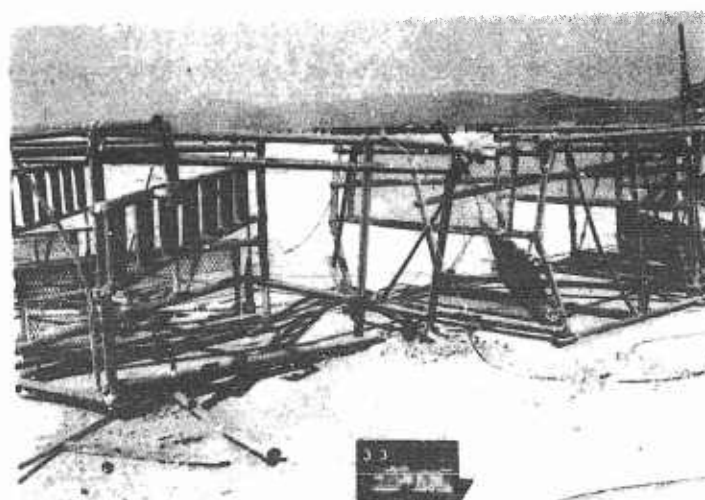
Fig. 3.87, Shot 9, Test Group 33, Tower, 120 ft. (See Fig. 3.129)
(Top-after, Bottom-after) 3350 ft, 51.5 cal, 9.8 psi.

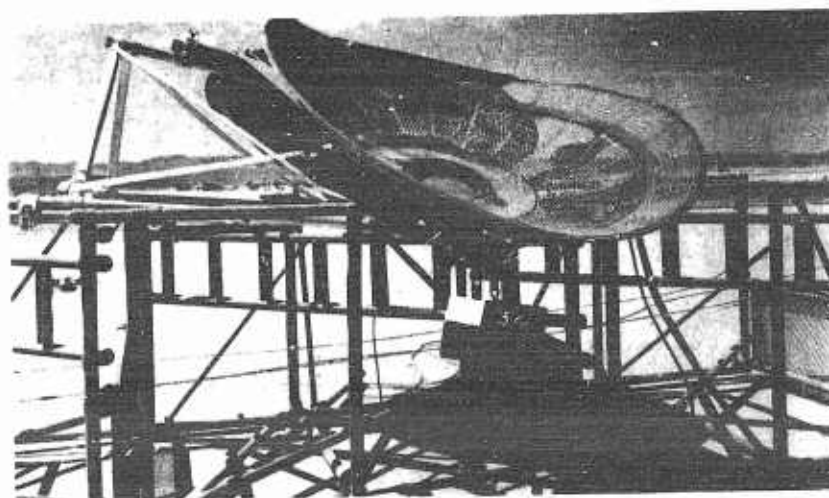
Fig. 3.89 Shot 9, Test Group 34, Tower, 120 ft.
(All after Photos Showing Damage Details.)
4350 ft, 36 cal, 7.2 psi.

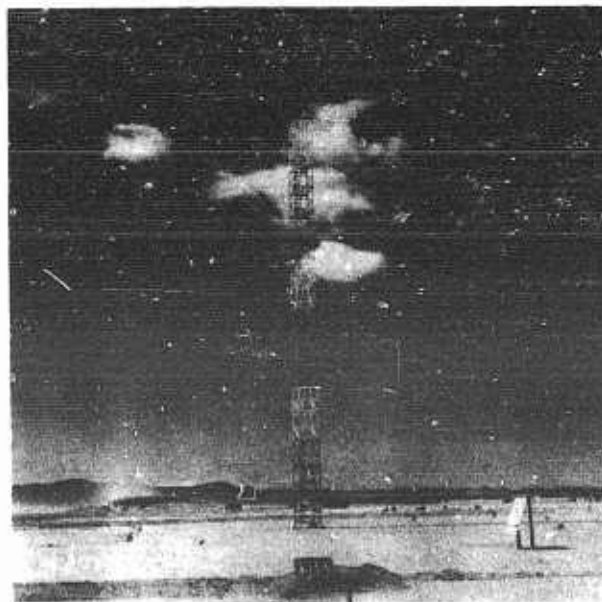
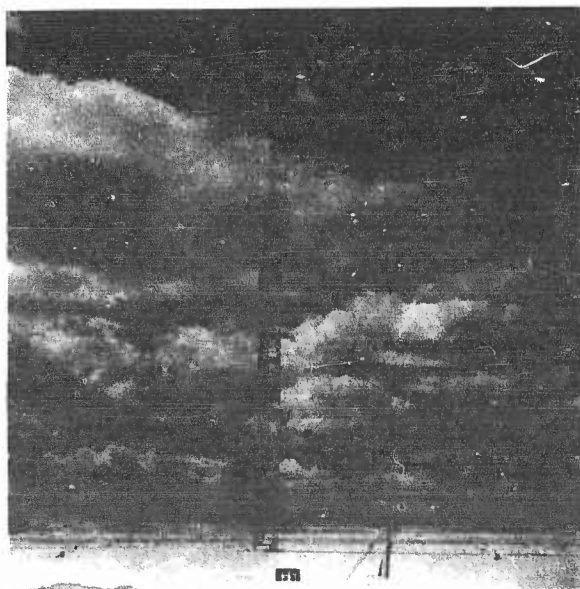
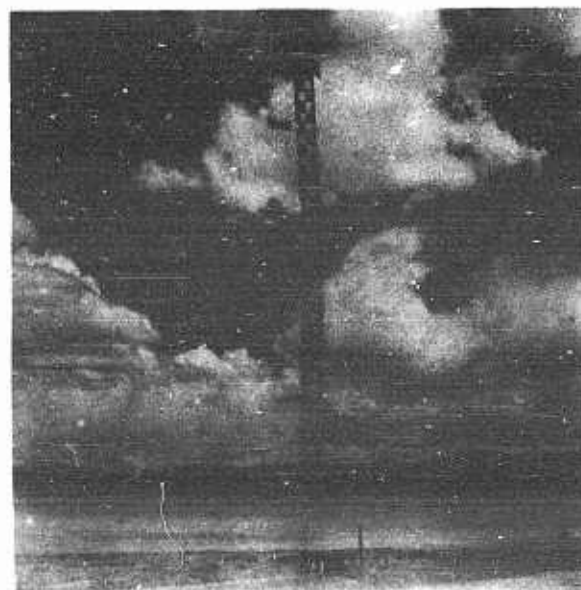
b. RESULTS: Severe damage by blast forces. Tower did not collapse but received sufficient damage to leave it unsafe for use. Parabolic reflectors, Davit MX-1215/U and the manila hauling line received no blast damage. Scaffold Tower Bracket MT-1157/G was slightly distorted. The tower base section had the two vertical members facing GZ bent toward the inside of the tower. The assembled tower twisted approximately 10° from the forth guy level to the top. The section above the fourth guy level was severely damaged with members twisted and bent. Some of the shackles at guy to anchor terminations were bent.

Fig. 3.90 Shot 9, Test Group 35, Tower, 120 ft. (Top-before, Bottom left-Side View Looking West-after; Bottom Right-Side View Looking East-after.) (Note Buckle in Tower.) 5350 ft, 19.5 cal, 4.6 psi.

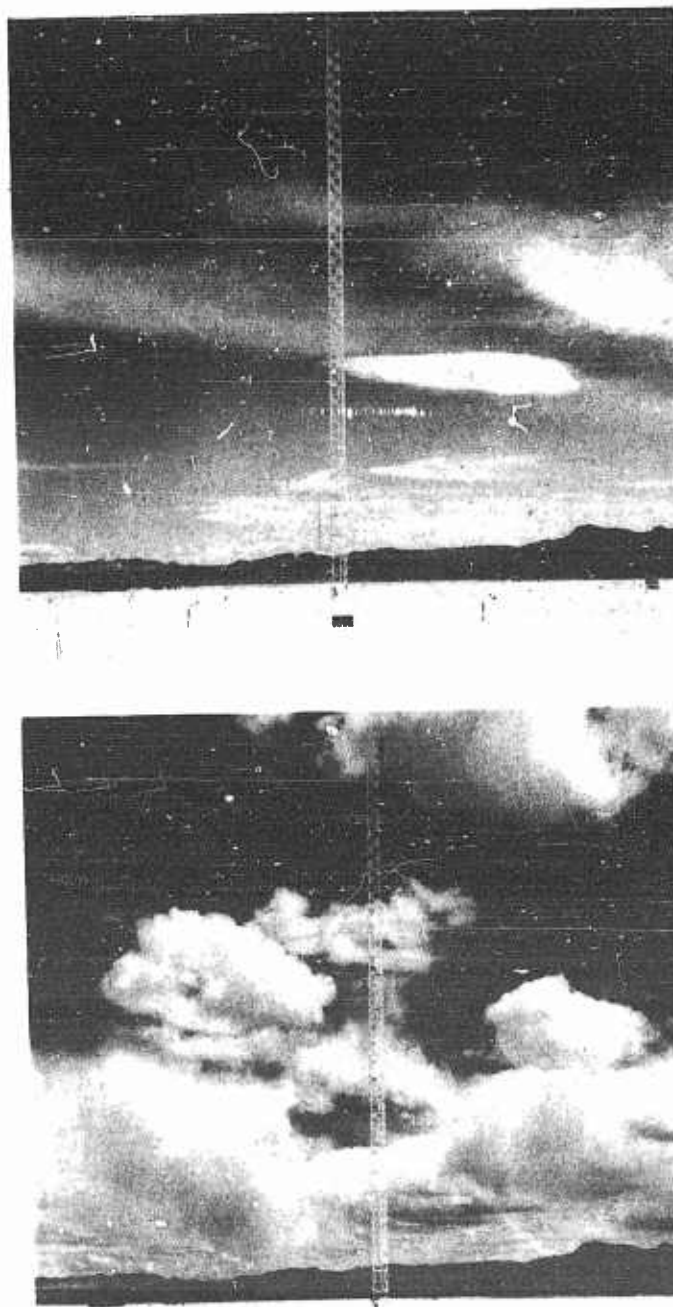
Fig. 3.91 Shot 9, Test Group 36, Tower, 200 ft.
(Top-before, Bottom-after)
6350 ft, 19.5 cal, 4.6 psi.

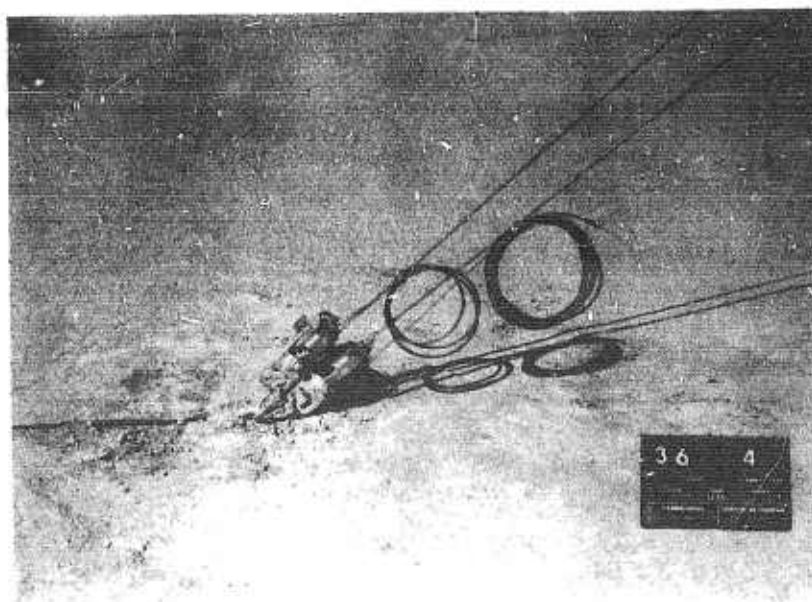
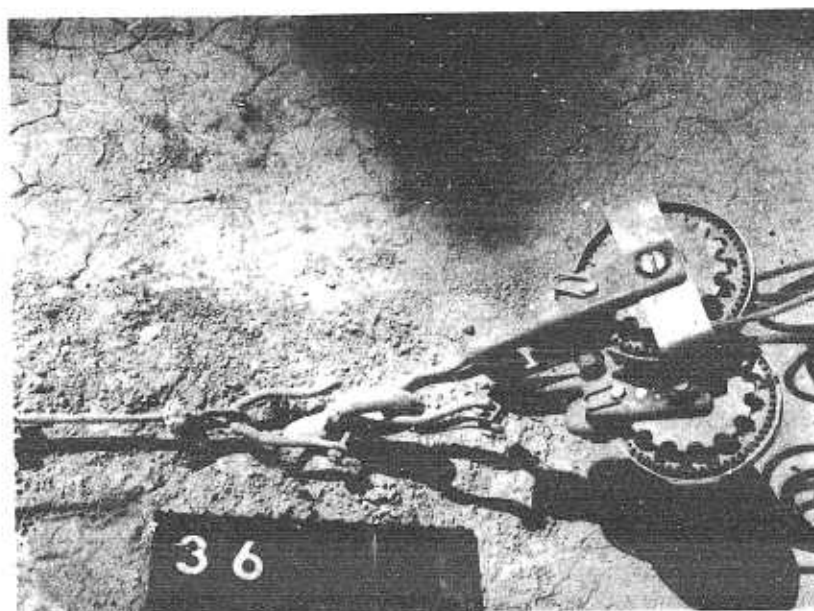
Fig. 3.93 Shot 9, Test Group 36, Tower, 300 ft, Clevice Details.
 (Top-before, Bottom-after) (Note Strain on Bolts.)
 6350 ft, 19.5 cal, 4.6 psi.

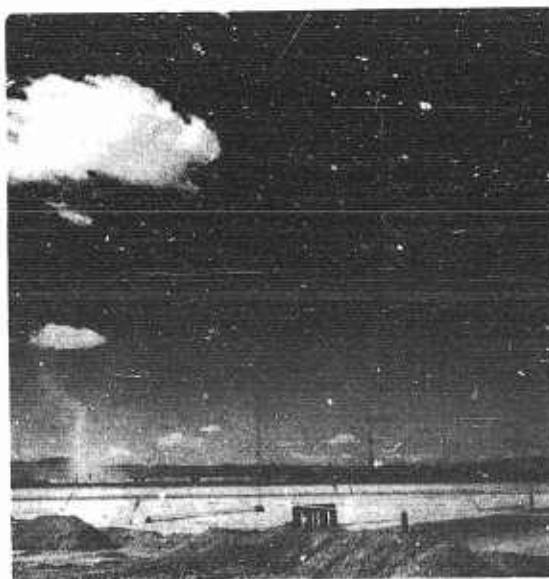
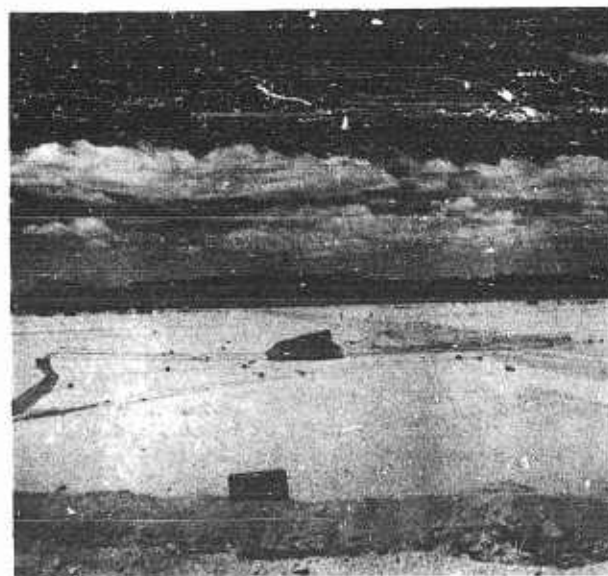
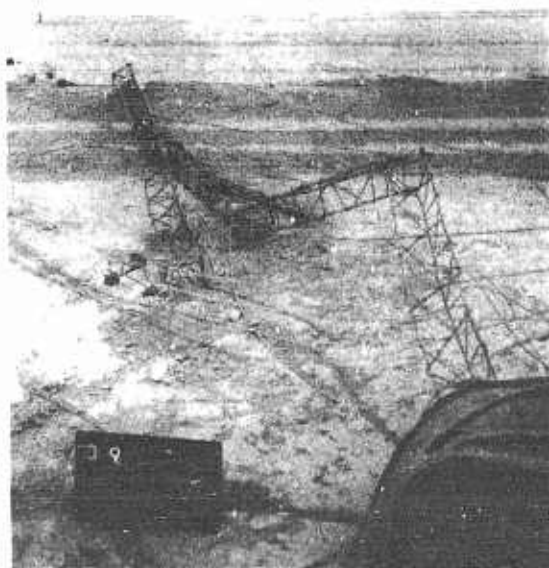
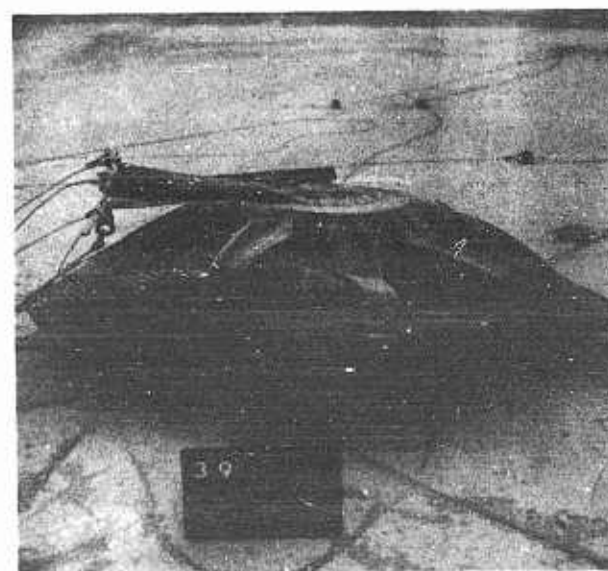
Support was severely damaged by the blast forces. The mast buckled at the joint of the third section from the top. The mast remained upright up to the joint of buckling. Because of the construction it would be necessary to replace the entire unit. Light thermal

Fig. 3.94 Shot 9, Test Group 39, Antenna Mast AB-26/CR. (Top left-
close-up, after; Bottom right-Reflector, after)
4050 ft, 40.5 cal, 8 psi.

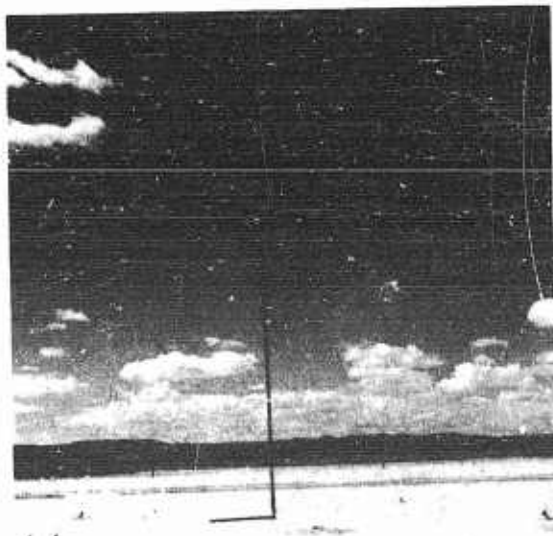
Fig. 3.98 Shot 9, Test Group 43, Antenna System, AS-19/TRC-1.
(Top left-before, Top right-after, Bottom left, bent
Mast-after, Bottom Right-Broken Top of Mast)
4900 ft, 29.5 cal, 6.2 psi.

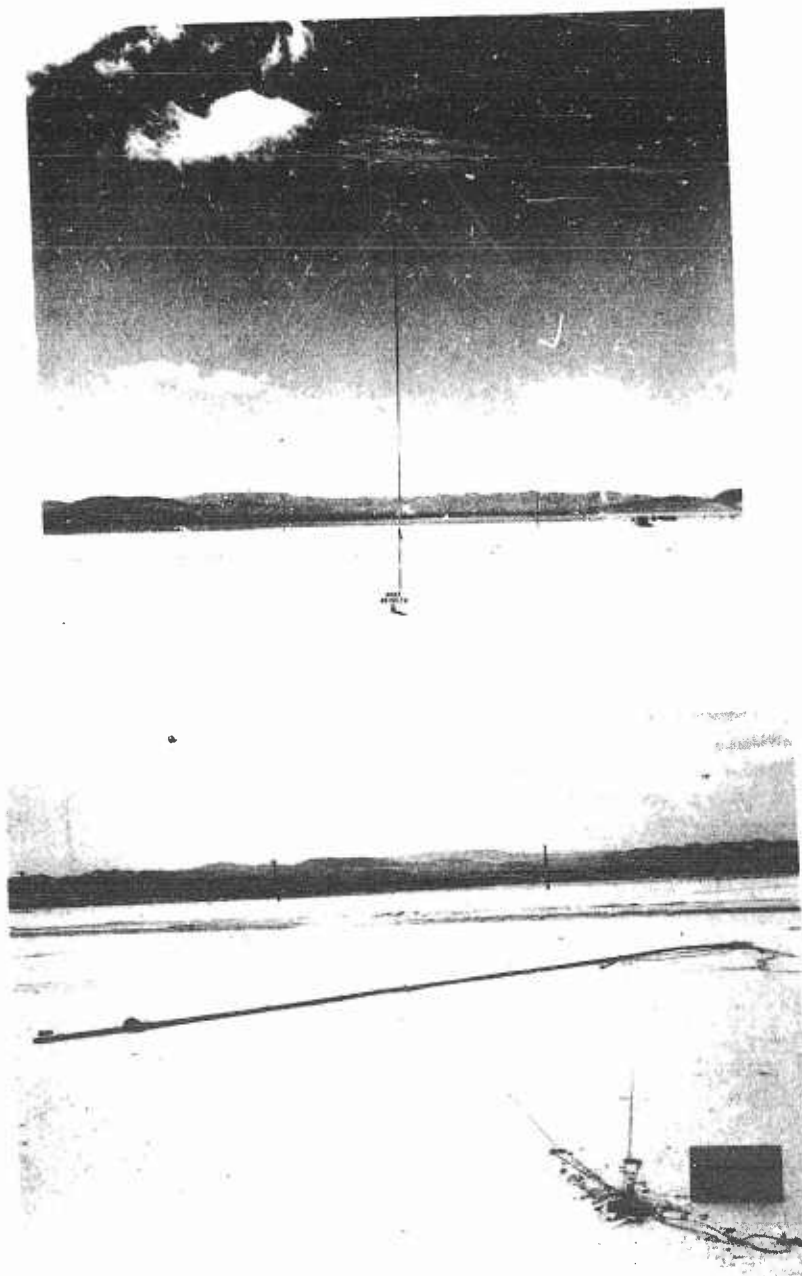
Fig. 3.99 Shot 9, Test Group 44, Antenna Mast AB-155/U.
(Top-before, Bottom-after)
4900 ft, 29.5 cal, 6.2 psi.

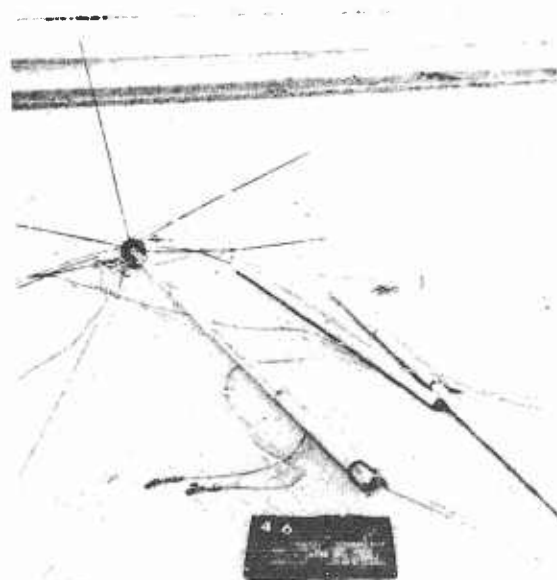
Fig. 3.101 Shot 9, Test Group 46, Magnesium Mast, 30 ft. (Top left-before, Top right-after; Bottom, Broken Mast Sections-after) 4950 ft, 29.5 cal. 6.2 psi.

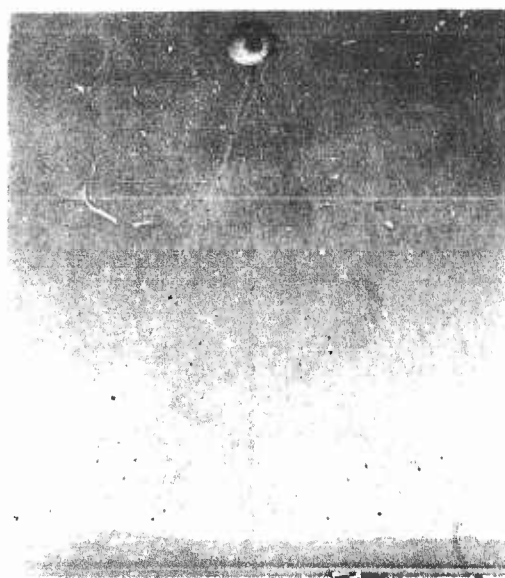
Fig. 3.104 Shot 9, Test Group 49, Antenna Mast AB-26/CR. (Top left-before, Top right-after; Bottom left, Section of Twisted and Broken Mast-after; Bottom right, Reflector-after.) 5550 ft, 25 cal, 5.4 psi.

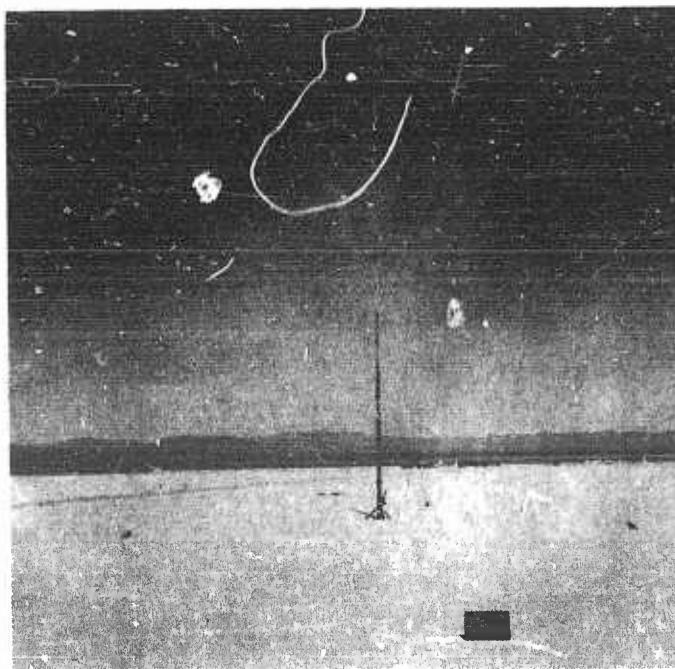
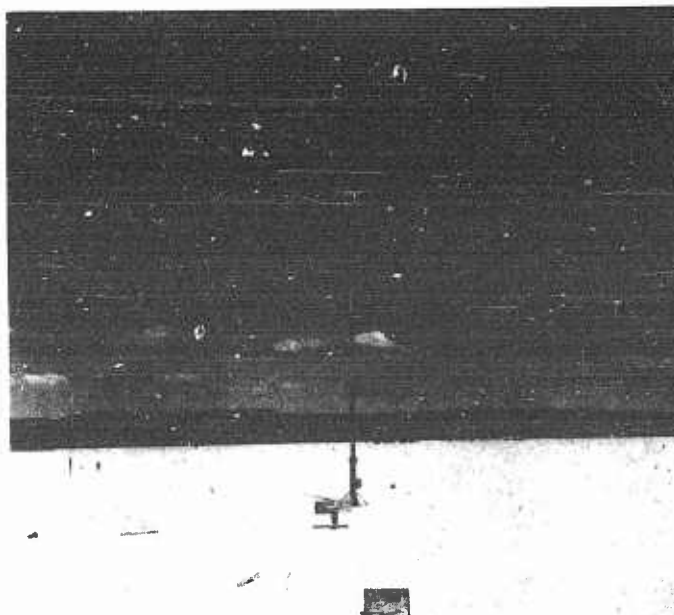
Fig. 3.105 Shot 9, Test Group 50, Antenna Mast AB-224/U.
(Top-before, Bottom-after)
5575 ft, 25 cal, 5.4 psi.

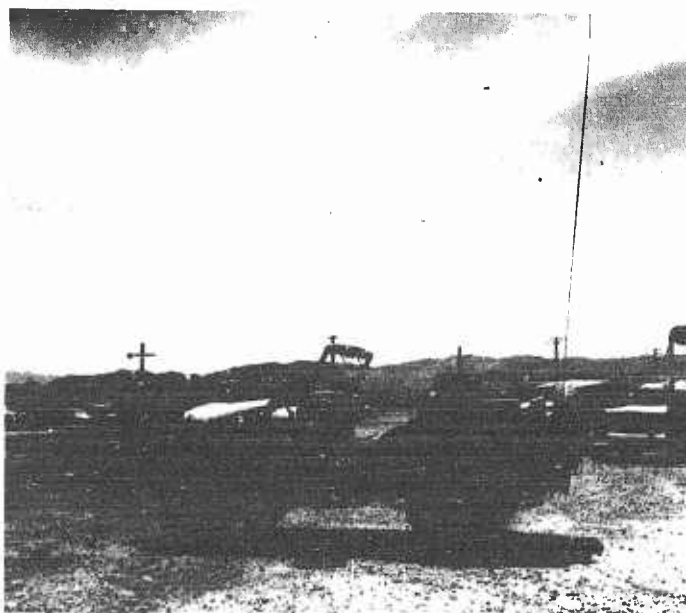
Fig. 3.124 Shot 9, Test Group 82, Radio Set AN/GRC-9 in Ordnance Jeep.
 (Top-before, Bottom-after. Bottom View Taken after Jeep
 had been Driven Under its Own Power from the Test Site.)
 4550 ft, 33.5 cal, 6.9 psi.

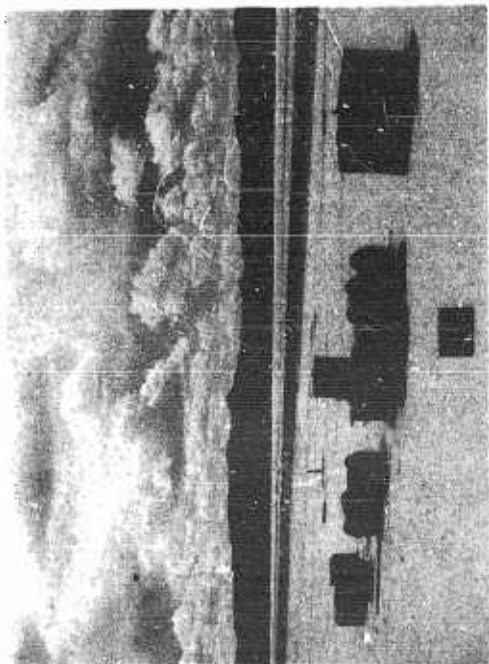
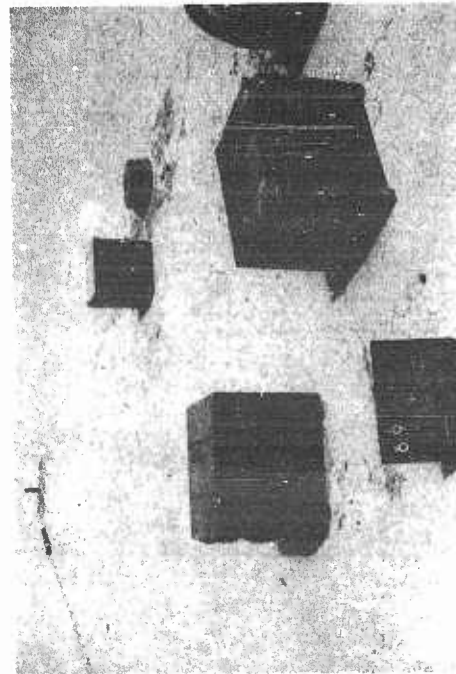
Fig. 3.138 Shot 9, Test Group 69, Signal Supply Point. (Top left-before, Top right-after, Bottom left, close-up of AN/TRC-1 Radio Set in Chests, Bottom right, close-up of AN/TRC-1 Radio Set, Chests open to Show Condition Inside.) 5625 ft, 24.5 cal, 5.4 psi, 80 r at Surface.

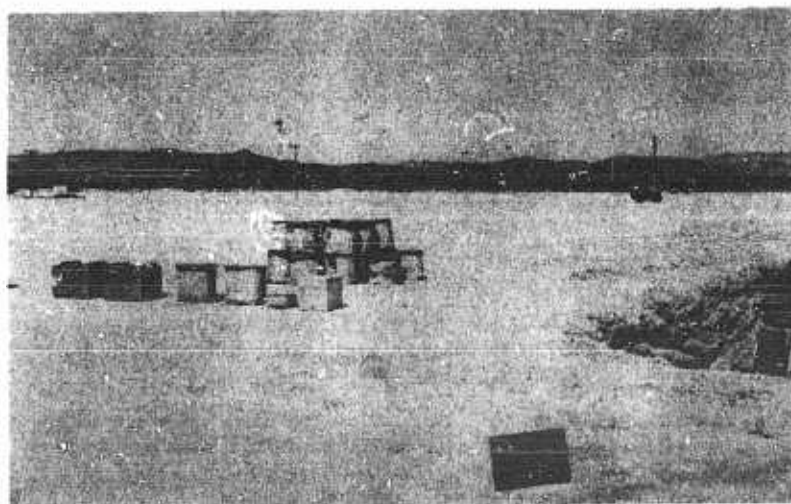
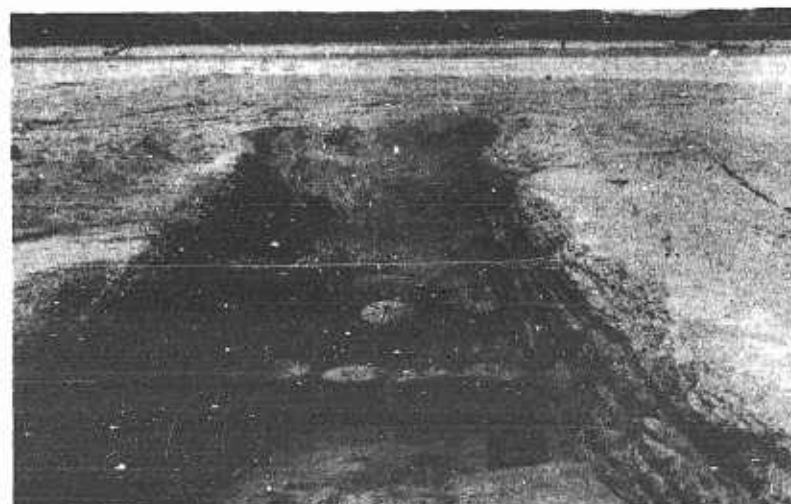
Fig. 3.139 Shot 9, Test Group 102, Signal Supply Point in Open Pit. (Top-before, Bottom-after) In Top View the Open Pit can be Seen to the Right of the Signal Supply Point on the Surface. 3150 ft, 55 cal, 10.2 psi, 1160 r at Surface.

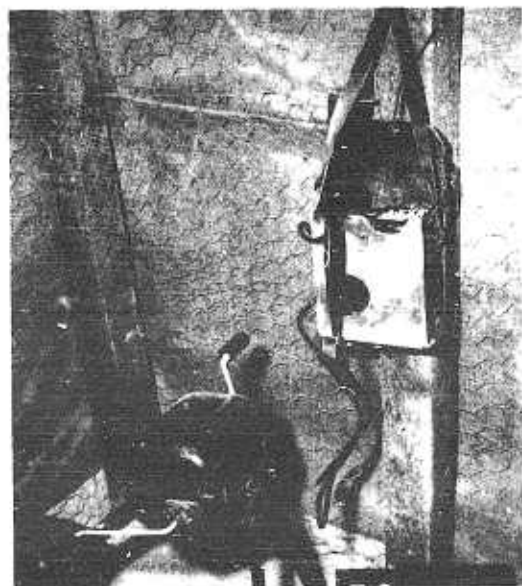
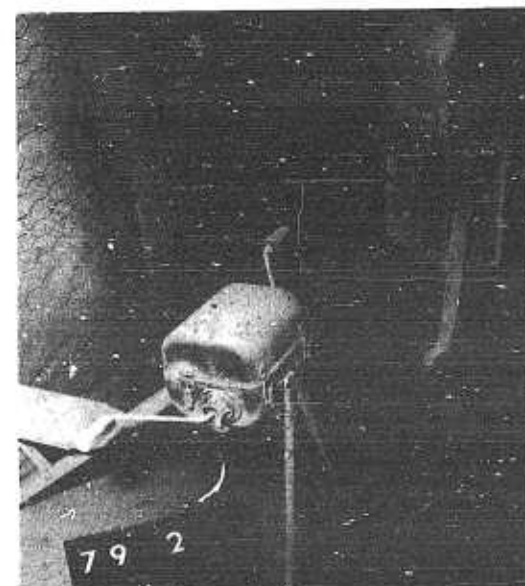
Fig. 3.153 Shot 9, Test Group 79, Signal Corps Items in Corps of Engrs. Installations (CO Type CP-Fig. 3.124). SB-22 Switchboard (Top left-before, Top right-after; GN-94 Generator and EE-8 Telephone (Bottom left-before, Bottom right-after) 4000 ft, 41 cal, 8 psi, 400 r at Surface.

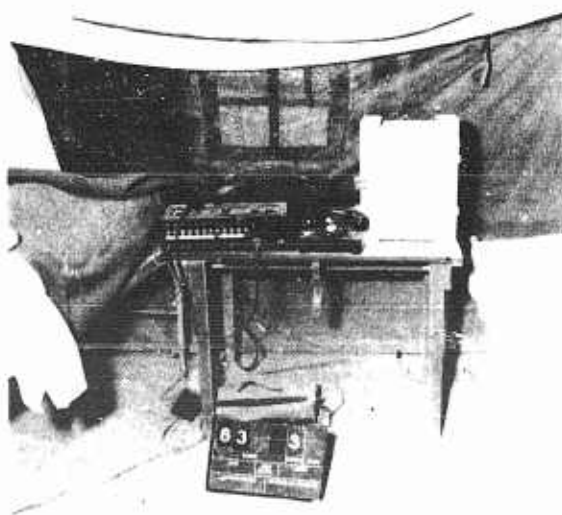
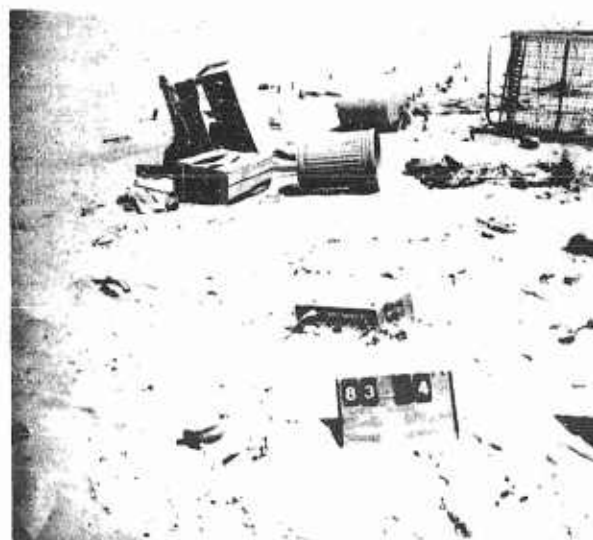
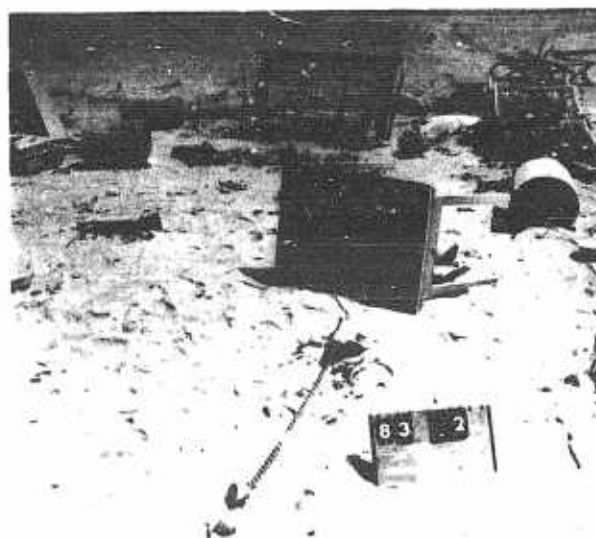
Fig. 3.154 Shot 9, Test Group 83, Signal Corps Items in Medical Corps Installations. (Field Hospital in Tents at the Surface.) (Top left-before, Bottom left-after; Top right, SB-22 Switchboard-after, Bottom right, close-up of Same Switchboard-after) 4125 ft, 39.5 cal, 8 psi, 320 r at Surface.

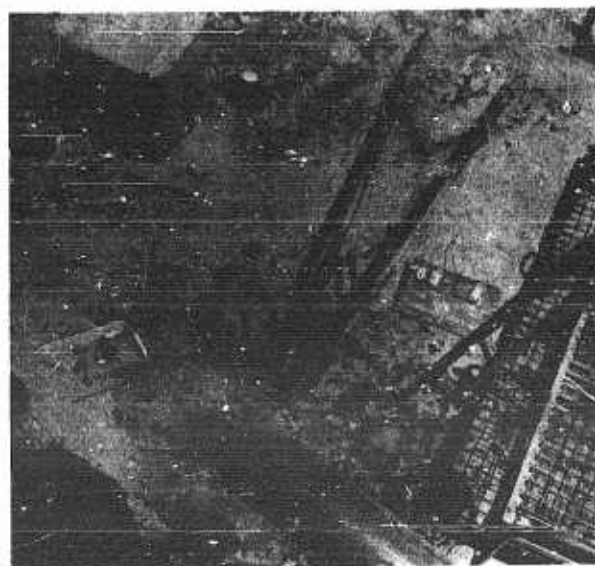
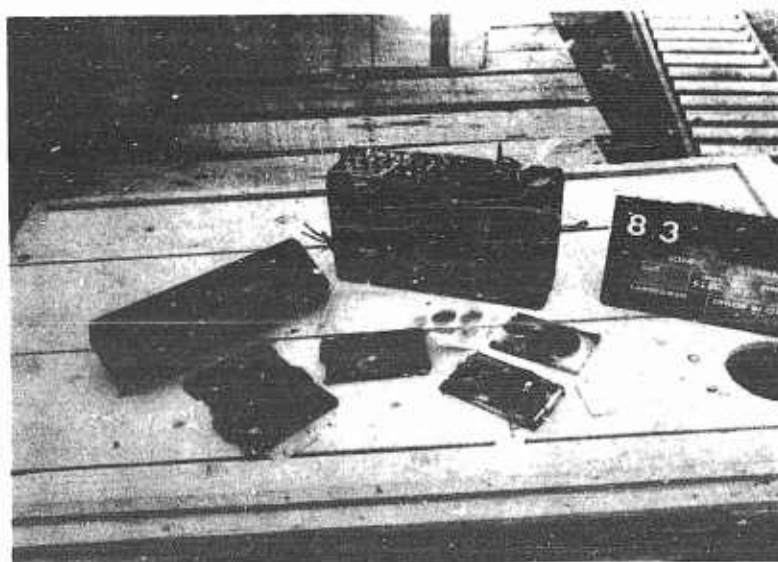
Fig. 3.155 Shot 9, Test Group 83, Signal Corps Items in Medical Corps Installations. (Field Hospital in Tents Revetted below the Surface.) (Top left-before, Top right-after, Bottom, SB-22 Switchboard-after) 4125 ft, 39.5 cal, 8 psi, 320 r at Surface.

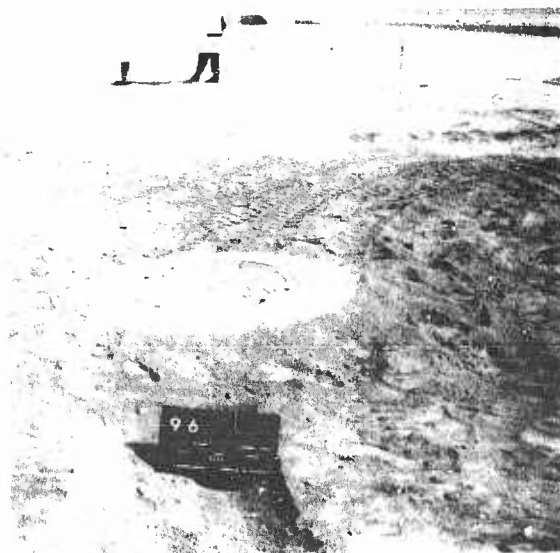
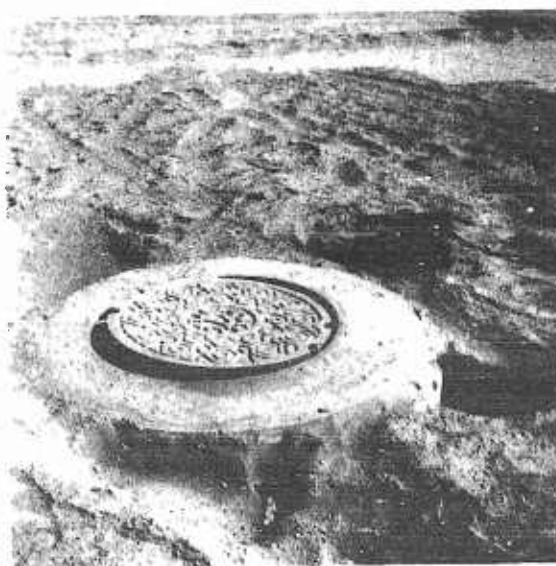
b. RESULTS: The manhole cover in Shot 9 (1250 ft, 113 cal, 16.6 psi), was lifted from its base and moved 1/2 in. There were several

In Shot 10 the manhole cover (600 ft, over 65 cal, over 115 psi), was forced into the manhole and covered with 1-1/2 ft of earth. The manhole (field constructed) was crushed in and filled with 1-1/2 ft

Fig. 3.156 Shots 9 and 10, Test Group 96, Manhole. (Top left-before 9, Bottom left-after 9; Interior of Manhole, Top right-before 9, Bottom right-after 9.) NOTE: The Manhole was destroyed in Shot 10. Shot 9 - 1250 ft, 113 cal, 16.6 psi. Shot 10 - 600 ft, over 65 cal, over 115 psi.
